**TOWN COUNCIL**  
**Work Session**  
March 31, 2022  
Cape Charles Civic Center  
6:30 PM

# Town Facilities Needs/Deficiencies Study

| CONDITION SURVEY | |

# Cape Charles Harbor Capital Management Plan

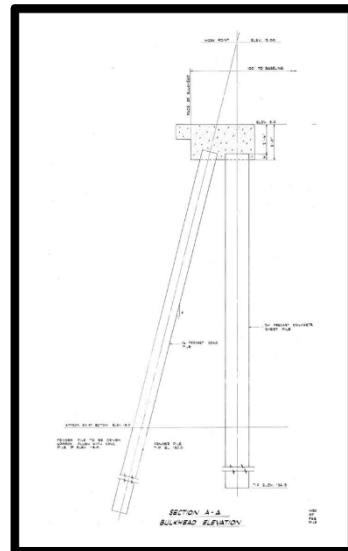
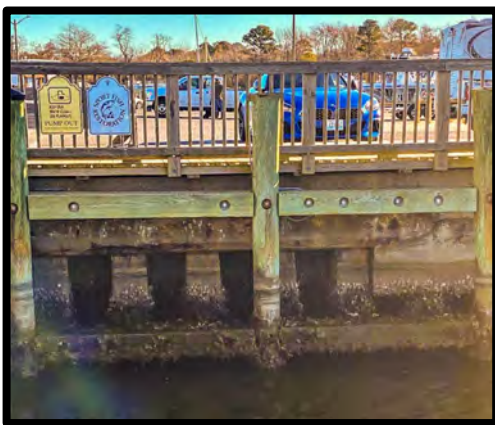
The concrete bulkhead extends approximately 800 feet from southeast of the Bath House adjacent to the rip-rap jetty. The bulkhead extends north to the Bath House and then west just past the Shanty Restaurant. It was difficult to get a close look at the concrete structure because the Timber Boardwalk is constructed over the bulkhead limiting access and obstructing the view. The bulkhead is constructed of precast concrete sheetpiles with a cast-in-place concrete cap similar to the structure at the Yacht Center at the southeast corner of the harbor. The sheetpiles are supported laterally by square, precast concrete reaction piles. The construction appears to change as it turns north at the Shanty. All that was visible at the time of our inspection was the concrete cap. Observations of this portion were also limited for the lack of good vantage points.

Based on our observations, the concrete bulkhead appears to be in **Fair Condition (5)**. According to the original construction drawings, the bulkhead structure is almost fifty years old. Our assessment is based on what we were able to see as well as previous observations of the similar structures referred to above. We observed some severe spalling and cracking of the concrete cap at several locations. This type of damage would be expected for a structure of this age. However, we could not get a close enough look to accurately document all the damage. We recommend a closer inspection including an underwater component.

The recommended replacement would be a steel sheetpile bulkhead due to the depth of water. The cost to replace the existing concrete bulkhead in this manner would be approximately \$2,500 per linear foot. This would include the sheetpiles, concrete cap and a new tieback system. The total cost for the entire length would be approximately \$2,000,000.

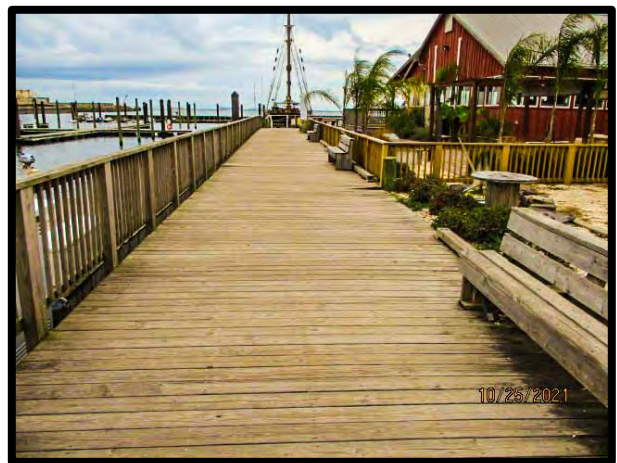
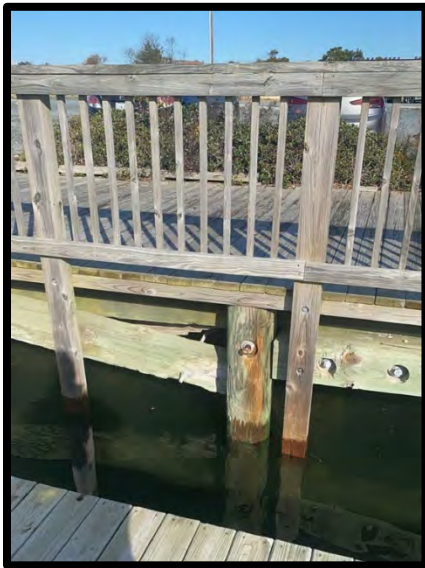
The boardwalk and railing is in **Good (7)** condition with the exception of a few maintenance items. We noted a condition where the top waler has broken away from the adjacent pile. It appears to be the result of some type of impact. We noted several loose

or disconnected bolts. The 2x6 deck is also in **Good (7)** condition. However, decking does deteriorate and gets damaged periodically. We suggest being proactive about replacing damaged decking and hardware each year.

We estimate the service life of the boardwalk and railing is approximately twenty years depending on maintenance. The service life can be extended with proper repairs and continued maintenance. We recommend regular maintenance where damaged sections of railing, decking, walers and piles are replaced in an as-needed basis. We recommend a closer inspection of the underside of the decking be performed to document all deficiencies in the underside of the timber structure. This may require a small boat or a diver.

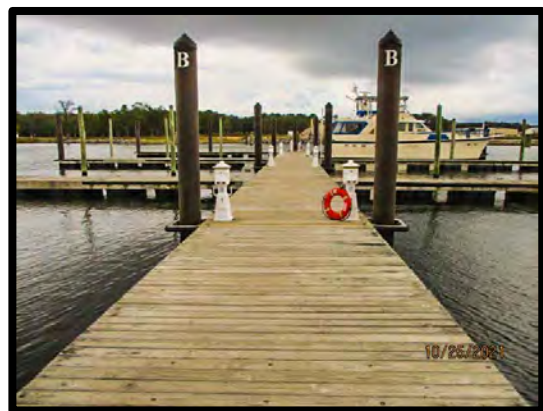
The floating dock system consists of three separate piers that extend into the harbor from the north side adjacent to the Shanty Restaurant. These docks are connected by a 600' long main dock that runs east to west and terminates at a floating wave attenuator that is oriented in the north-south direction. The existing wave attenuator is approximately 130' long. The docks and floats appear to be in **Good (7)** condition. However, we noted that several of the anchor piles

are worn and are badly corroded. This was mostly observed on the wave attenuator. We also noted that several of the external pile guides are in **Poor (4)** condition. The rollers are worn down and there is metal rubbing against metal. Several of the piles on the wave attenuator have experienced section loss from friction from the damaged pile guides. This will accelerate the deterioration of the piles from

corrosion from the saltwater environment. There are approximately 12 - 15 pile guides that need to be replaced in the near future. Otherwise, the life of the anchor piles will be severely reduced. If the guides are repaired, the remaining service life of the anchor piles is approximately ten years. If they are not repaired, it could be as little as two to three years.

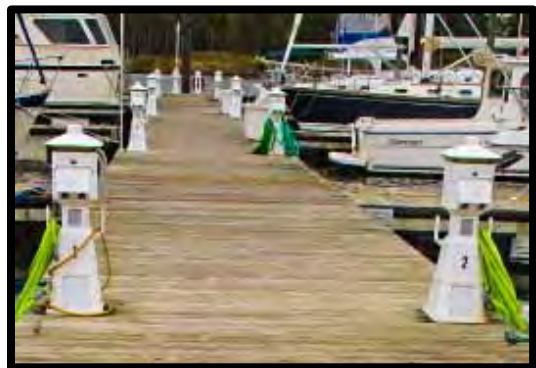
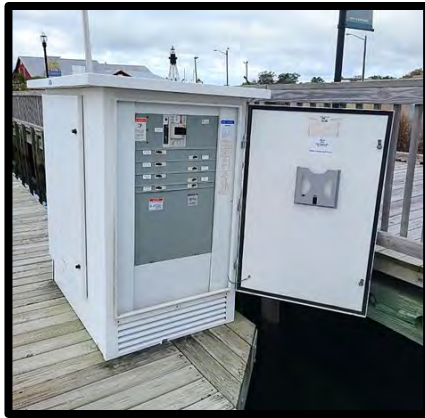
Electrical service pedestals S1, S2, and S3 are rated 700A at 240/120V, 1-phase, 3-wire. The service equipment was manufactured in 2011 and is in good condition. Some corrosion is present, which is expected considering the proximity to the water and associated salt-laden environment. Each service pedestal has an integral transformer to step the incoming 480V service voltage down to 240/120V. The service

pedestals are fed from Panel “P” rated 800A at 480/277V, 3-phase, 4W. This panel is manufactured by Eaton, PRL4 series, manufactured in February 2011, and is in good condition.

Utility service pedestals for power and water are generally in fair condition. Most of the pedestals are rated 140A max, 120/240V, 4-wire and are manufactured by Marina Power and Lighting, Inc., “Hatteras” model. Some corrosion is present, which is expected considering the proximity to the water and associated salt-laden environment. Most lenses are yellowing, which is expected outdoors. Some covers were missing and should be replaced.

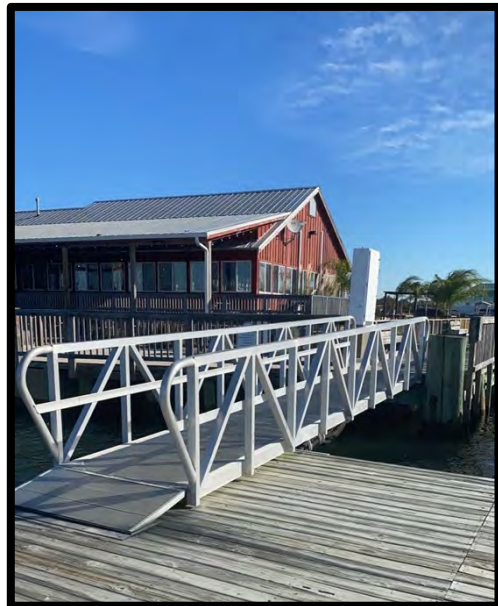
There are two aluminum gangways that access the floating docks from the timber boardwalk. Both are approximately forty feet long. One is located near the bath house on the east end of the timber boardwalk and the other is located at the west end by the Shanty Restaurant. Both gangways are in **Good (7)** condition with no apparent defects. We estimate that the service life would be up to thirty years. It will be important to monitor the connections and hinges. These items can deteriorate over time but can be repaired or replaced as needed.

Replacement cost for similar aluminum gangways would be approximately \$50,000 each.

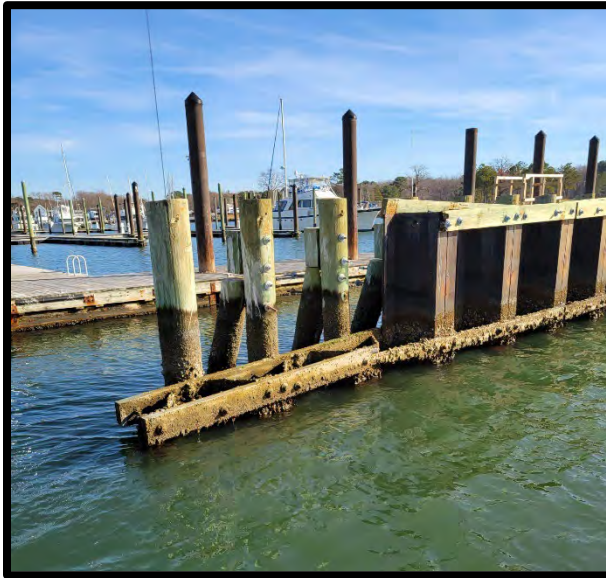
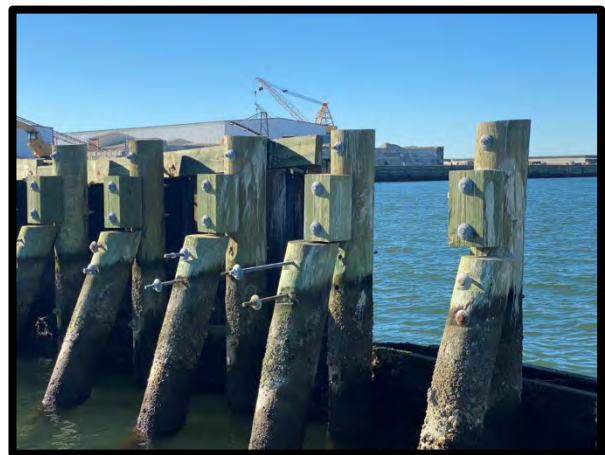
## 4. Fixed Breakwater

The fixed breakwater is constructed of steel sheetpiles and timber piles and walers. The timber piles are configured with a vertical pile and a battered piles spaced at 4' on center. The sheetpile pairs alternate between fully embedded and stopping at elevation -12.0 ft. There are two continuous walers; one at the top at +8.0 ft and the other at mean low water. The original design was 230' long with a deck surface and protective dolphins and fender piles. In addition, the existing floating wave attenuator and a portion of the floating dock was to be relocated to the north. The project scope was reduced because of budgetary constraints. The wave attenuator was not moved, about half of the proposed

It is our understanding that the breakwater was impacted by a barge or large vessel resulting in significant damage. Currently, the sheetpiles and walers for the northernmost 10' are missing from sight. At least another 20' of the sheetpiles are no longer supported laterally and move back and forth with wave action. Several bolts have sheared which would be consistent with a side impact. This has severely compromised the remaining section of the breakwater.

The fixed breakwater is in **Poor (2)** condition and could fail under severe storm conditions. Currently, about 80' – 90' of the existing structure can be salvaged if a repair effort is implemented soon. We recommend replacing the missing members and sheared bolts. A thorough, close-up investigation from a boat should be performed where all connections are tested so that all broken bolts can be identified and replaced. We also suggest protective dolphins be installed at either end. The best scenario would be to repair the existing breakwater and complete as much of the original scope of work as possible.

The approximate cost of the recommended repair is \$120,000. To further reinforce and stabilize the breakwater structure, it would be advisable to add another wale and bolt the inside flange to the back to the pile bents. This would add another \$44,000 to the repair costs. In addition, to help protect the structure from future impacts, we recommend installing four three pile dolphins at an additional \$32,000.

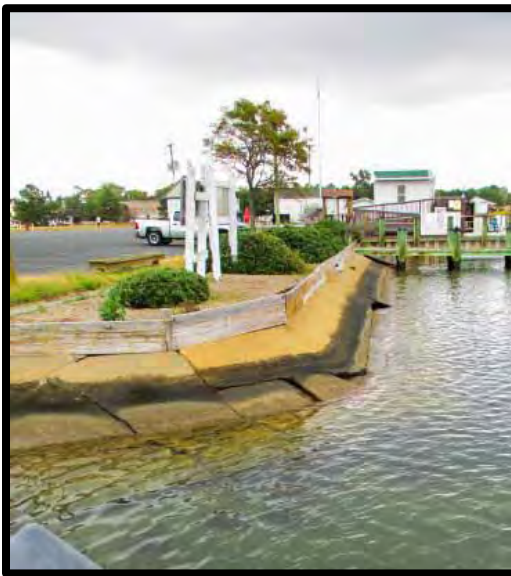
### 5. Sloped Concrete Revetment

The shoreline between the boat ramps and the Dockmaster is protected by a sloped, concrete revetment. The revetment is at an approximate angle of 30° from horizontal and extends from below the mudline to about 3' above mean high water. It appears to be constructed with cast-in-place concrete slabs-on-grade of unknown thickness. The concrete revetment is in **Fair (5)** condition with several cracks in the slabs. There is severe cracking at the corner near the boat ramp. In spite of these conditions, the concrete revetment appears to be serving its purpose adequately. We estimate the service life of the concrete revetment is approximately ten years.

As it deteriorates, it can be reinforced with rip rap at a cost of approximately \$60,000.

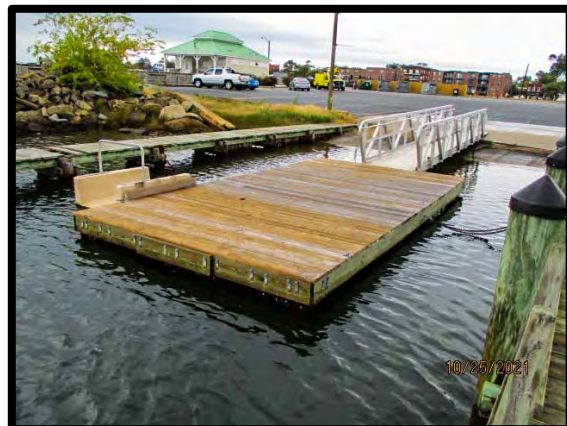
The kayak launch consists of a floating dock system with timber framing and decking. Attached to the side is a mechanism to assist handicapped kayakers. An aluminum gangway provides access to the floating dock from the northernmost and unused boat ramp. The landside of the gangway rests on a 4x4 timber that appears to sit directly on the concrete ramp surface. The floating dock is held in place by chains that attach to the adjacent fixed piers. The kayak

launch appears to be in **Good (7)** condition. A severe high tide could submerge the landside of the gangway. Typically, these dock systems are secured with anchor piles with pile guides. This may not be possible in this location because of the concrete boat ramp over which it's placed. Typically, the service life for structures like this is approximately twenty-five years. In its current installation, it may not survive a severe weather event that included a significant storm surge.

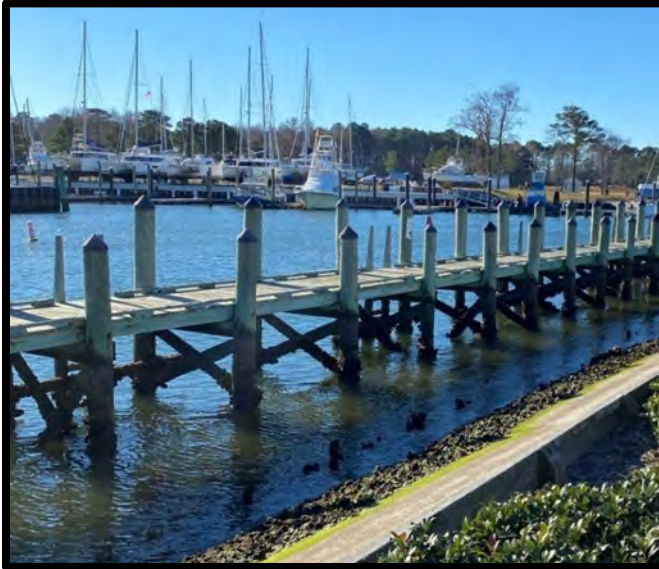
There is a system of fixed docks serving multiple boat ramps under state authority, and 1 fixed dock between the ramps and the Dockmaster. The fixed docks consist of timber pile bents 8' on center with two, 3x10 girders at each bent. The bents support 2x8 stringers spaced 16" on center with 2x6 wood decking. There is a rail on the perimeter that consists of a continuous 2x4 over 2x4 blocking for a height above the deck of three inches. The docks are constructed relatively low to the water and the girders are submerged at high tide. The hardware is corroded and will

require replacement over the next few years. The fixed pier farthest to the west is in **Serious (3)** condition with severe deterioration to the timber piles and supporting members. This pier should be replaced or demolished in the near future. The remaining fixed docks are in **Satisfactory (6)** condition. We estimate the remaining service life at approximately fifteen years. With proper maintenance and prompt repair of damaged and deteriorated members, the service life could be extended another ten years.

We estimate that approximately fifteen percent of the decking should be replaced within the next twenty-four months. We did not note any damaged timbers during our inspections. However, it would be prudent to program for minor repairs and replacement of a modest amount of damaged or deteriorated members.

We were not able to accurately evaluate the piles below the water line. Therefore, we recommend engaging a qualified diving company to perform a level one, visual underwater inspection of all the piles. We estimate the remaining service life to be approximately fifteen years. This can be extended with maintenance and repair/replacement of damaged members.

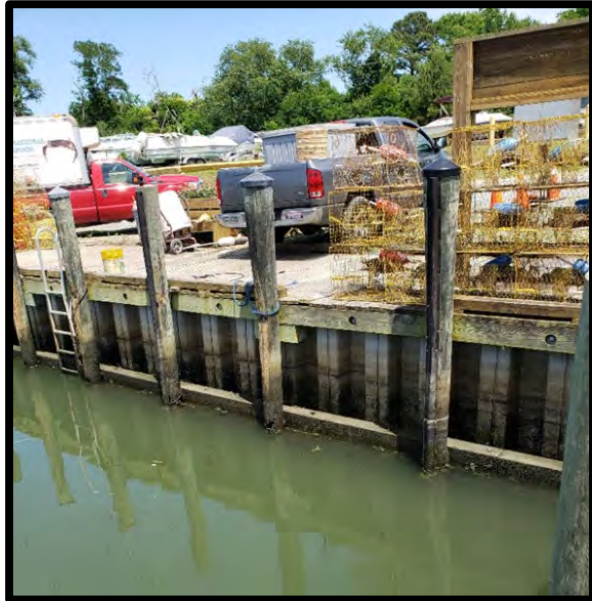
The bulkhead around the Inner Harbor is constructed of vinyl sheetpiling with one 8x8 timber waler at the top and one just above low water. There are 8" diameter king piles at approximately 6' on center with a steel rod tieback at each pile. We do not have any information on the length nor the composition and depth of the deadman. We understand that some of the tiebacks were exposed when the concrete slab was installed a few years ago and they appeared to be in **Good (7)** condition according to town personnel. Considering the entire structure, the vinyl bulkhead is in **Fair (5)** condition. This rating is based mainly on the condition of the king piles and lower walers. There are numerous piles that are either broken or damaged by abrasion of commercial boats riding up and down with the tide. Approximately twenty percent of the lower walers have deteriorated and lost significant cross-sectional area. If these deficiencies are repaired, the condition rating would be elevated to **Good (7)**. If it is not repaired, the wall may experience local failures that would be expensive to fix.

We estimate that there is approximately twenty years of service life remaining. The limiting factor for the service life is the timber and the steel hardware. If these items are maintained by regularly replacing damaged timbers and rusted hardware, the service life can be extended an additional ten years.

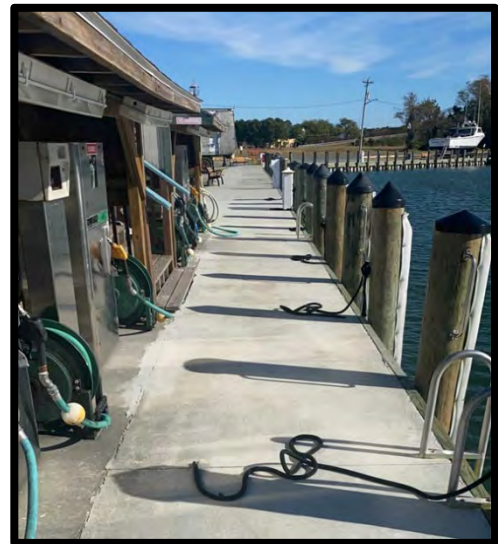
The concrete boardwalk that surrounds the Inner Harbor appears to be in **Very Good (8)** condition. We understand that this slab was constructed within the last few years. Our office provided preliminary construction documents for this slab in October of 2019. Those drawings called for a 6" slab on grade. However, it is apparent that the slab that is in place was not constructed per our drawings. Our drawings indicated a continuous joint just inside of the bulkhead as a designed crack to account for future slab settlement. We did not observe any settlement or cracking at the time of our inspection. Any future

The existing concrete boardwalk is in **Very Good (8)** condition and will likely not require replacement until the vinyl bulkhead described above is replaced.

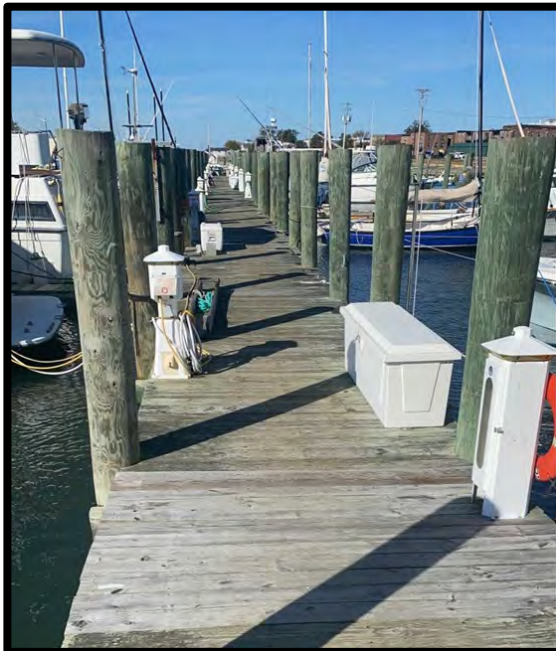
## 9. Fixed Docks

The fixed dock and finger piers in the Inner Harbor serve as boat slips for both commercial and pleasure craft. The construction consists of timber pile bents 8' on center with two, 3x10 girders at each bent. The bents support 2x8 stringers spaced at 16" on center with 2x6 wood decking. The finger piers are constructed with two 3x10 girders out to another timber pile and is also decked with 2x6 decking. We do not have any construction documents for these structures, and we do not have any information on when they were built.

The condition of the fixed docks and finger piers are in **Satisfactory (6)** condition with some minor section loss and missing or unattached diagonal braces. We estimate the remaining service life at approximately ten to fifteen years. With proper maintenance and prompt repair of damaged and deteriorated members, the service life could be extended another ten years. Most of the hardware is corroded, especially at the girder connections. We estimate that approximately fifteen percent of the bolts need to be replaced within the next twenty-four months. The decking is worn and deteriorated in several locations. We estimate that approximately fifteen percent of the decking should also be replaced within the next twenty-four months. We did not note any major damage to the main timbers

during our inspections. However, we did note that some of the diagonal braces have deteriorated. It would be prudent to program for minor repairs and replacement of a modest amount of damaged or deteriorated members each year.

We were not able to accurately evaluate the piles below the water line. Therefore, we recommend engaging a qualified diving company to perform a level one, visual underwater inspection of all the piles. We estimate the remaining service life to be approximately fifteen years. This can be extended with maintenance and repair/replacement of damaged members.

The current configuration is not an efficient use of harbor water space. The best solution for replacement would be a floating dock system. The cost of a floating dock system can vary greatly depending on the area of floating dock and configuration. A replacement floating dock system compatible with the current size and number of slips would cost approximately \$1,500,000 in today's dollars.

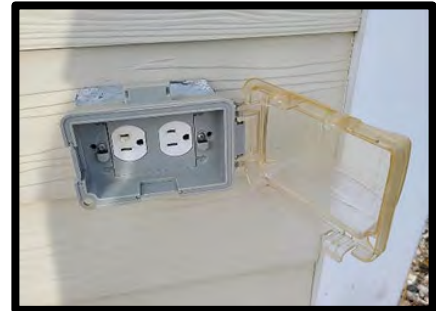
All exterior receptacles installed at the bath house should be replaced with ground fault interrupter (GFI) type receptacles with weatherproof while-in-use covers in accordance with current code requirements. GFI type receptacles are installed in wet locations indoors as required.

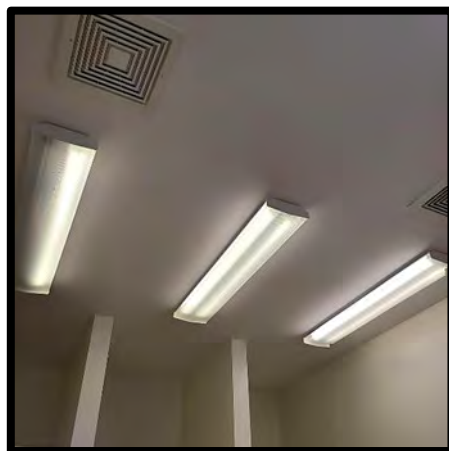
The existing interior lighting consists primarily of approximately older linear lensed fluorescent fixtures. Several were damaged with cracked lenses, and some had inoperable lamps. All interior lighting should be replaced with high efficiency LED lighting with appropriate lighting controls per current energy codes. All interior exit lights and emergency battery units (EBUs) were found to be inoperable during the site inspection and should be replaced. Exterior lighting fixtures are recessed fluorescent downlights. These downlights should be considered for replacement with LED equivalent types during any proposed upgrades. The exterior lights were noted to be on when it appeared sufficient daylight was present, and several had yellowing or missing lenses. Recommend confirming proper operation of exterior photocell and replacement as required. Exterior emergency egress lighting should be added at all exterior egress doors in accordance with code.

Budgetary cost for the lighting system replacement and replacement of GFI receptacles and covers is \$15,250.

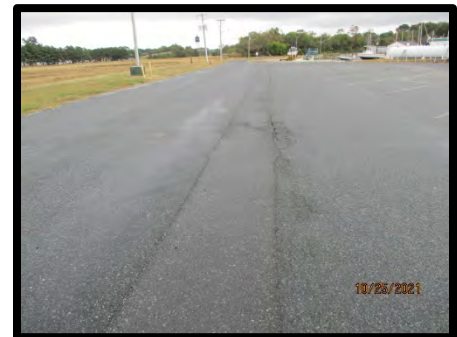
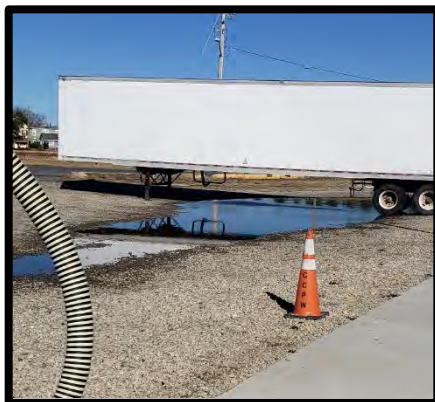
The asphalt drive and parking lot are in good condition. The pavement had been cut for utility line installation, but it appears the cuts were properly patched and sealed. There was some cracking adjacent thereto that should be sealed to avoid moisture penetration.

An additional issue concerning poor site drainage was observed with ponding in the gravel parking area where commercial vessels are serviced, just east of the Dockmaster. The area subject to ponding should be filled to direct runoff further east to an existing drop inlet.

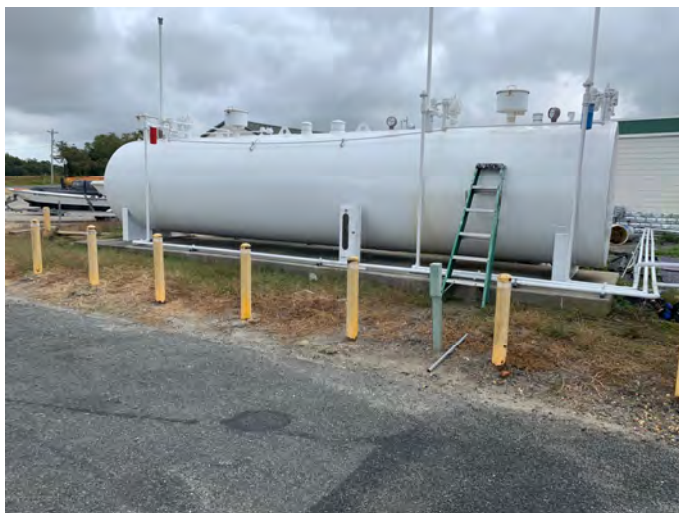
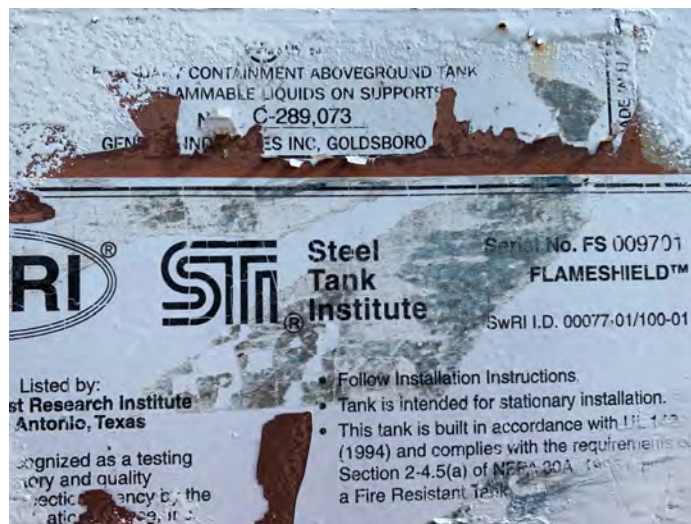
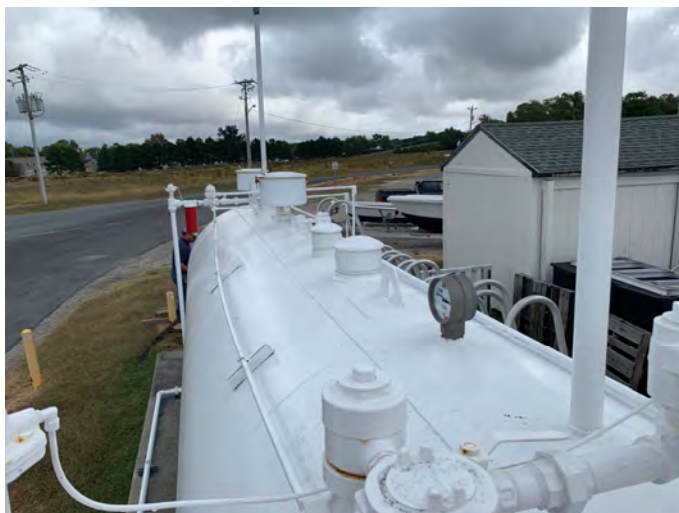
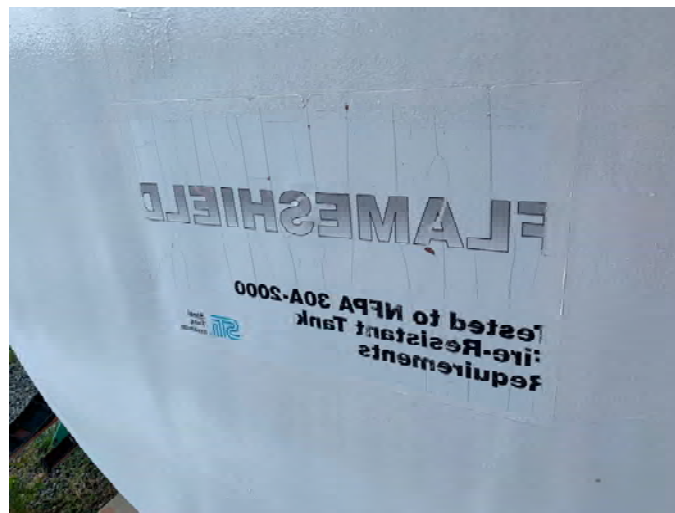
Tank needs one Vapor vent installed, one compartment has an improper Tank vent installed.

Pnumerator audible overfill alarm is inoperable may require replacement this is a DEQ requirement for overfill protection.

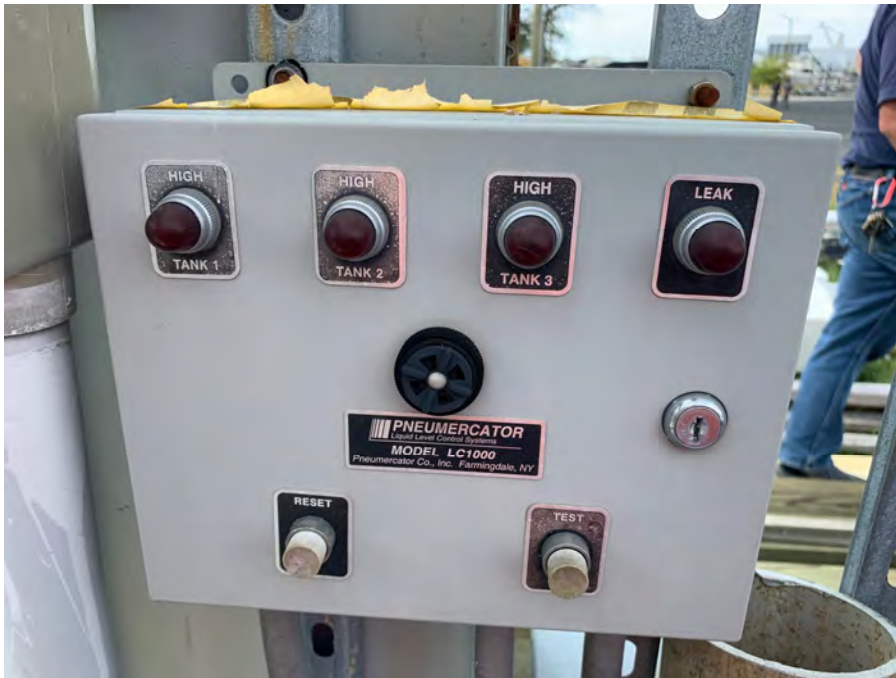
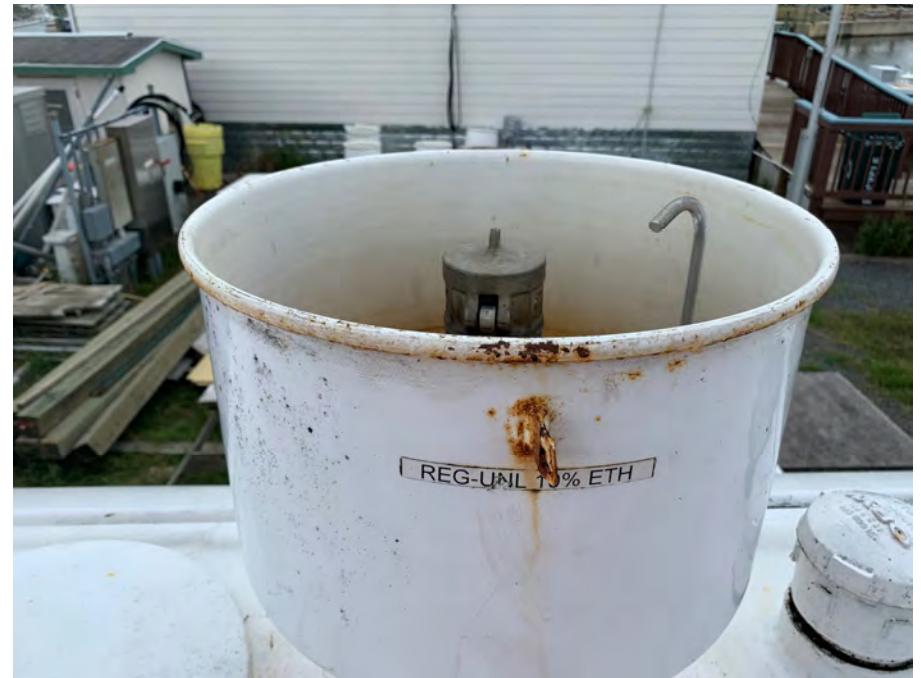
Needs Pressure Vacuum vent on one Gas compartment, (not pictured). One compartment has the proper vent one doesn't.

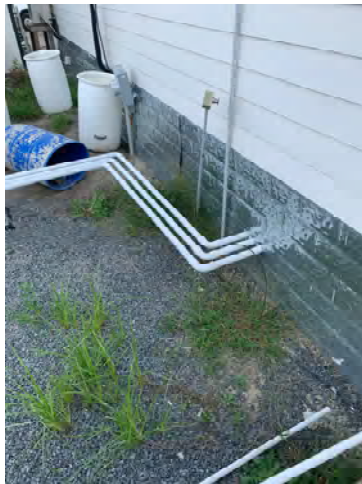
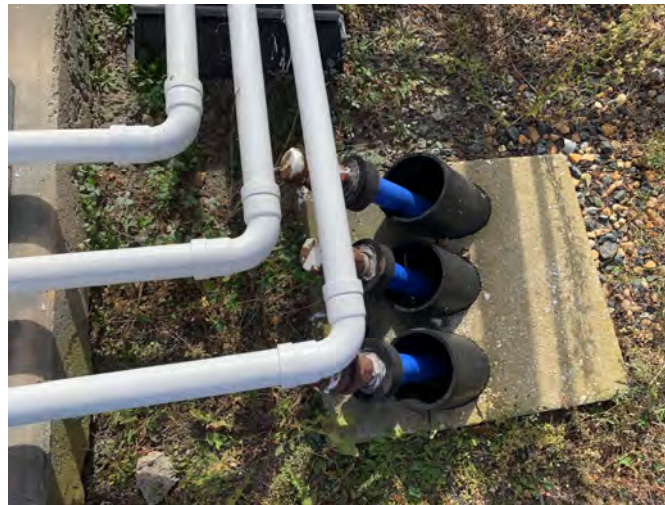
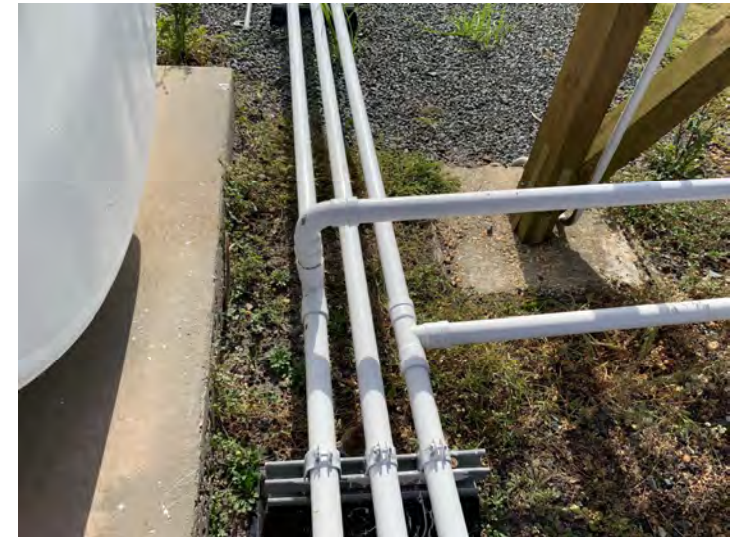
# Fuel product Piping

No leaks or irregularities noted.

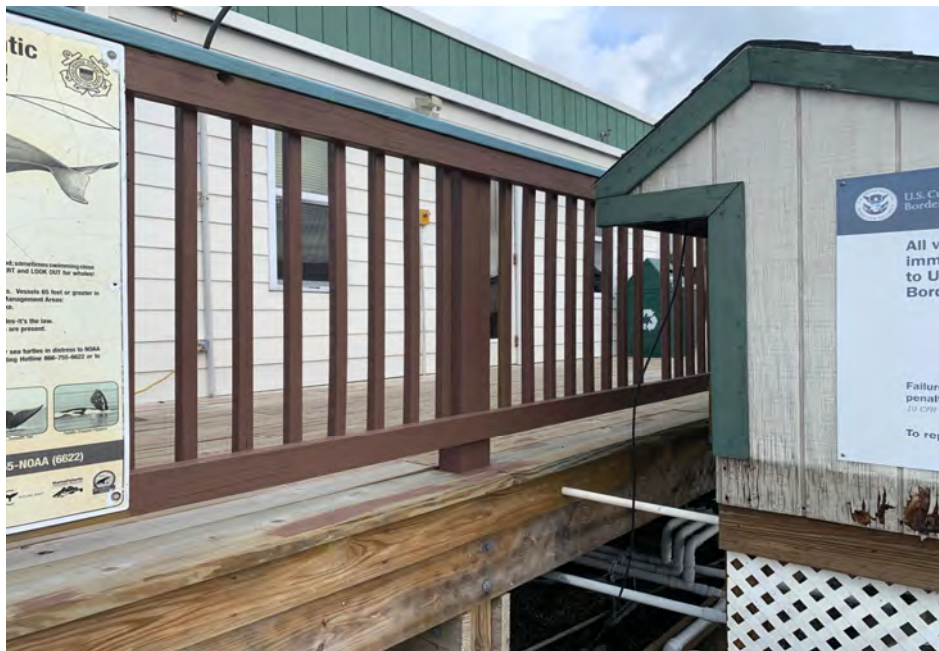
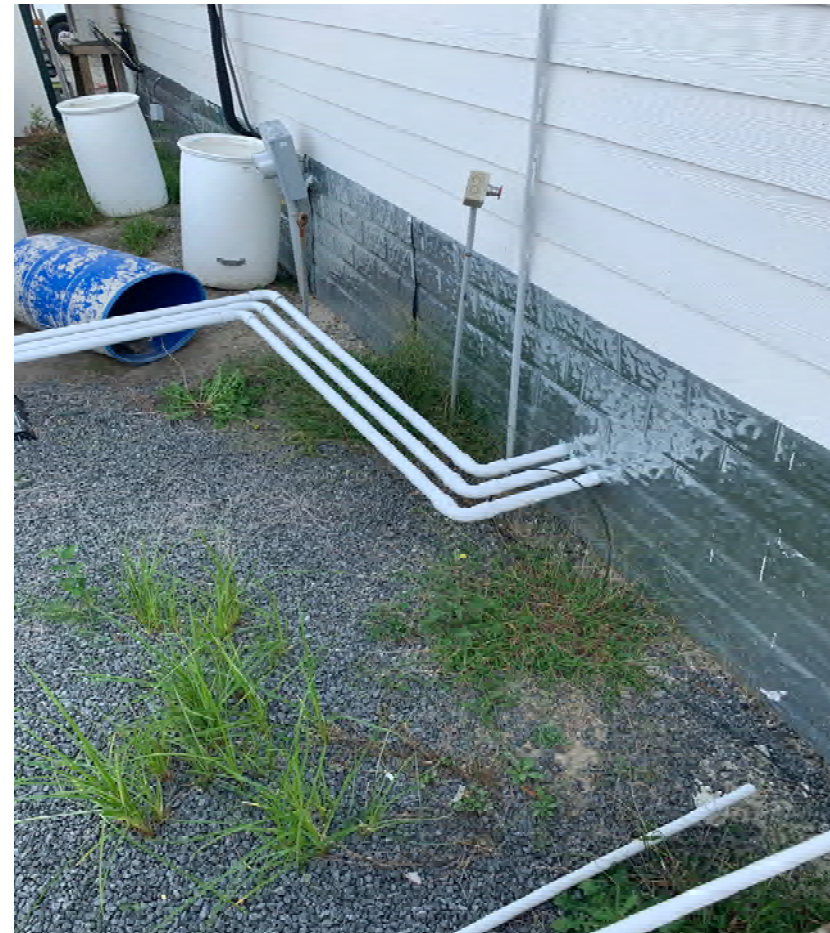
# Fuel Dispensing Emergency Stop Switches

Stop switch behind Tank is not attached and conduit is broken. No Signage

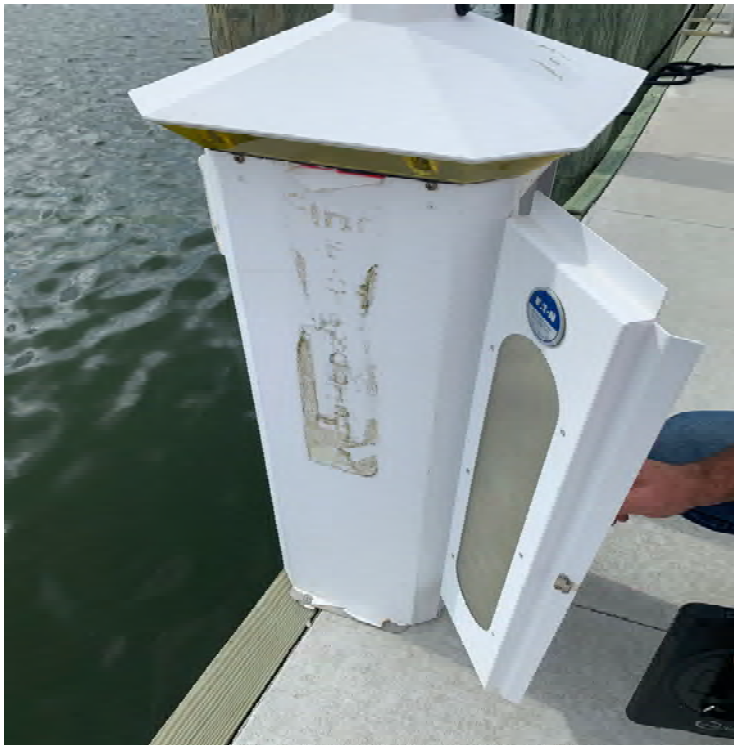
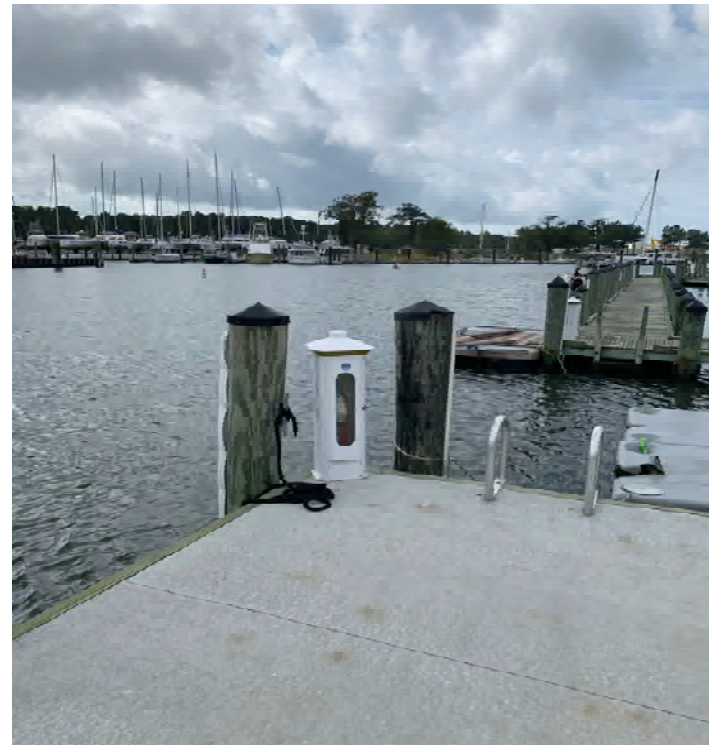
# Fire Extinguishers

Cabinets on the dock adjacent to the water are not attached properly and very dangerous.

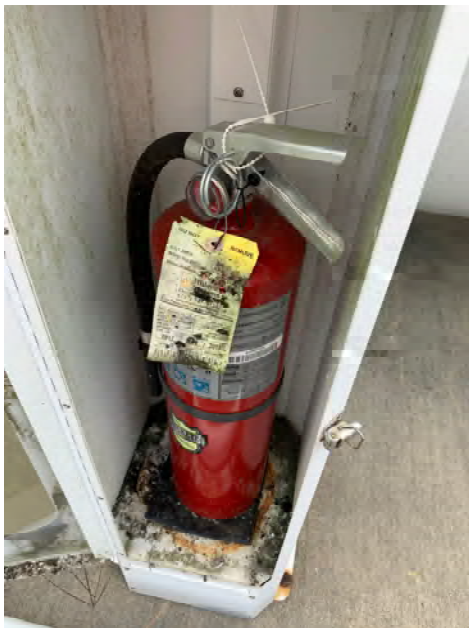
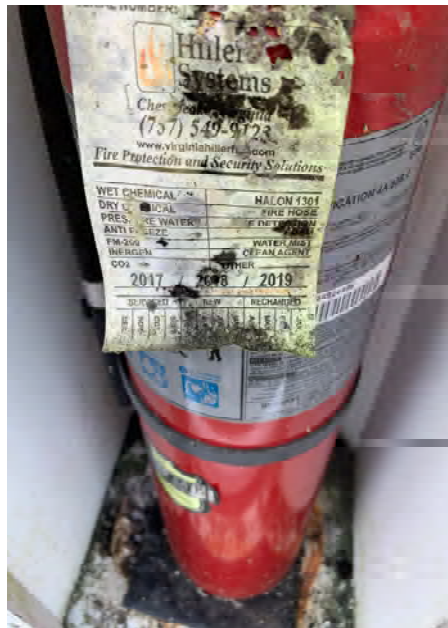
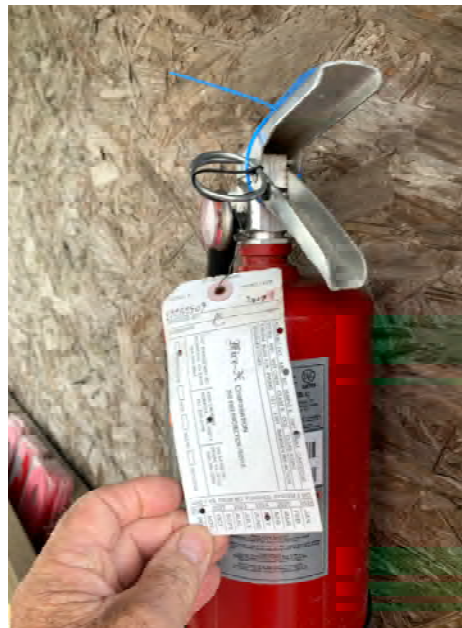
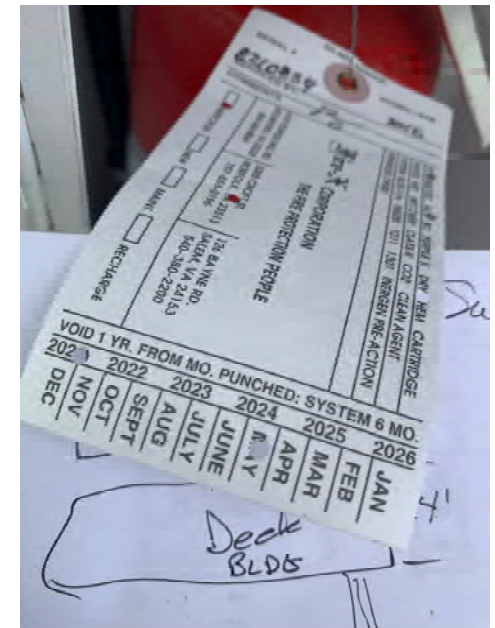
# Fire Extinguishers

- Fire extinguisher condition

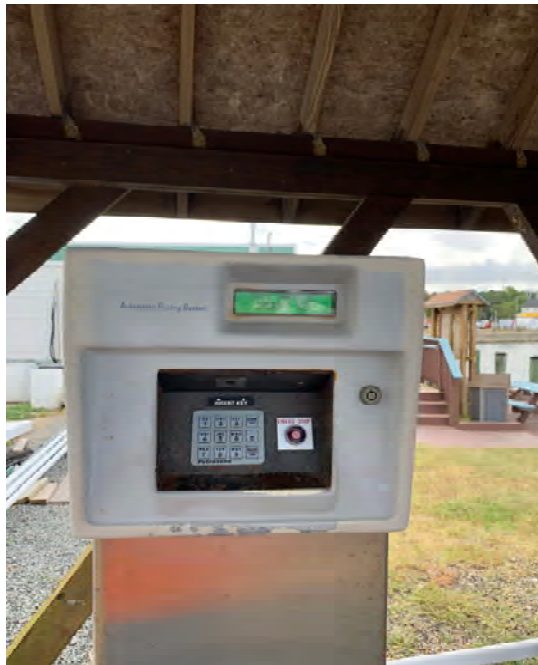
# Fuel Management system

Fuel management system is not connected to all dispensers and does not record all transactions. System is outdated and in need of upgrades. We would need more information on the needs of the end user to determine system recommendations.
