**TOWN COUNCIL**  
**Work Session**  
March 31, 2022  
Cape Charles Civic Center  
6:30 PM

# Town Facilities Needs/Deficiencies Study

| CONDITION SURVEY | |

# Cape Charles Harbor Capital Management Plan

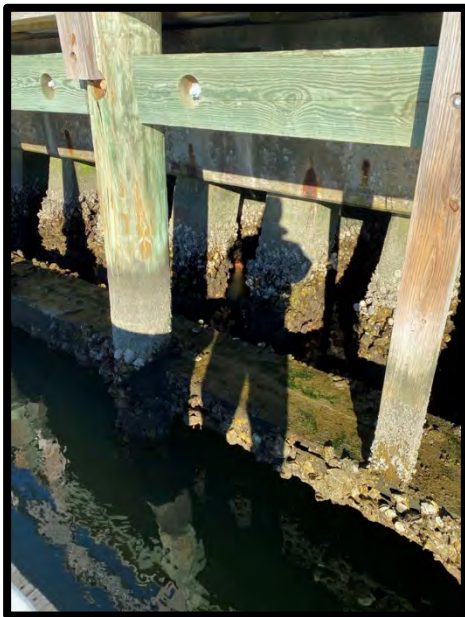
Based on our observations, the concrete bulkhead appears to be in **Fair Condition (5)**. According to the original construction drawings, the bulkhead structure is almost fifty years old. Our assessment is based on what we were able to see as well as previous observations of the similar structures referred to above. We observed some severe spalling and cracking of the concrete cap at several locations. This type of damage would be expected for a structure of this age. However, we could not get a close enough look to accurately document all the damage. We recommend a closer inspection including an underwater component.

It is difficult to estimate the remaining service life of the existing concrete bulkhead. Based on similar structures in the harbor, we estimate that there is another twenty years of service life remaining before a replacement effort will be necessary. The service life can be extended by repairing existing cracks and spalls. This process should be repeated every five to six years. Bulkhead replacement is complicated by the existing precast concrete reaction piles battered seaward into the harbor.

The recommended replacement would be a steel sheetpile bulkhead due to the depth of water. The cost to replace the existing concrete bulkhead in this manner would be approximately \$2,500 per linear foot. This would include the sheetpiles, concrete cap and a new tieback system. The total cost for the entire length would be approximately \$2,000,000.

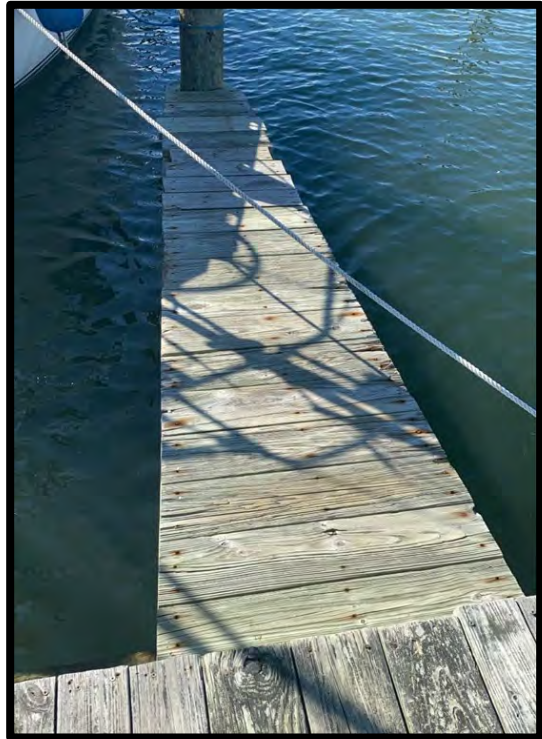
We were not able to accurately evaluate the piles below the water line. Therefore, we recommend engaging a qualified diving company to perform a level one, visual underwater inspection of all the piles. We estimate the remaining service life to be approximately fifteen years. This can be extended with maintenance and repair/replacement of damaged members.

The current configuration is not an efficient use of harbor water space. The best solution for replacement would be a floating dock system. The cost of a floating dock system can vary greatly depending on the area of floating dock and configuration. A replacement floating dock system compatible with the current size and number of slips would cost approximately \$1,500,000 in today's dollars.

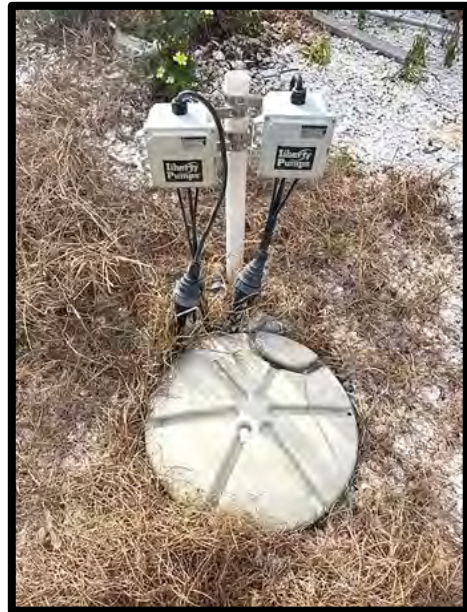
preventer: \$1,500. Sanitary waste discharges into a duplex sewage lift station, which appears to be in good operating condition. The water piping was noted to be PEX throughout. The sanitary waste and vent systems generally consist of PVC piping. Based on the age and condition of the system, minor repairs may be needed throughout the building. Domestic hot water is currently generated by two gas-fired tankless water heaters. Each water heater is in good condition. Plumbing fixtures generally consist of flush tank water closets, countertop and ADA wall-mounted lavatories, and shower stalls. Most fixtures appear to be in good operable condition. Shower area drainage needs to be addressed since improper floor slope lets water pool at the door.

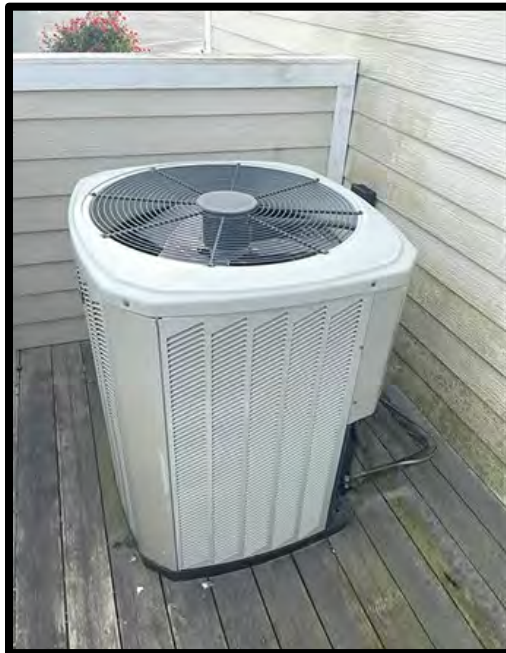
Existing HVAC system for the bath house consists of two split system heat pumps. Each system is 2.5-ton capacity heat pump with electric emergency heat. Units were manufactured by Trane and were installed in 2011. Systems appear to be in good working order and should last another 5 years. Typical service life for this type of equipment is approximately 15 years. Outdoor unit enclosure appears to be too close to the units, limiting service and operating clearances. Restroom and showers have individual exhaust fans, but it is not clear how these are controlled. Recommend adding some type of occupancy control to the exhaust fans so that they do not operate 24/7. We would also recommend adding dehumidifiers to each shower areas to reduce the humidity during summertime operation, since the existing system do not offer direct dehumidification. Approximate construction cost for the recommendations is \$5,000.

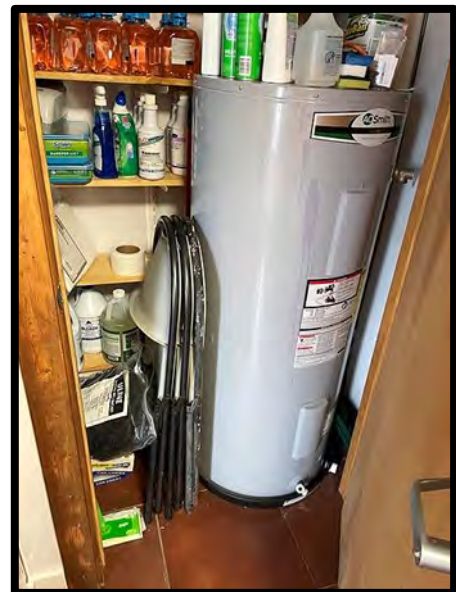
The plumbing systems in the building currently consist of domestic water, sanitary waste and vent systems, water heating systems, and various fixtures throughout the building. The existing water service is fed from the municipal water system and distributes to fixtures by a mixture of PVC and copper piping, except the laundry room water piping, which is noted to be CPVC. The domestic water service is not currently protected from cross contamination, at variance with the statewide water purveyor requirements. A reduced pressure principle backflow preventer will need to be added to the domestic water service as part of any work performed in the building. Estimated cost of backflow preventer \$1,500. Sanitary waste discharges into a duplex sewage lift station, which appears to be in good operating condition. Based on the age and condition of the systems, minor repairs may be needed throughout the building. Domestic hot water is currently generated by a residential style electric tank water heater. The water heater is in good condition, though the drain pan needs drain piping to a safe location. Plumbing fixtures generally consist of flush tank water closets, countertop, and ADA wall-mounted lavatories. Fixtures appear to be in good operable condition. Budgetary Cost for drain pan piping: \$750.

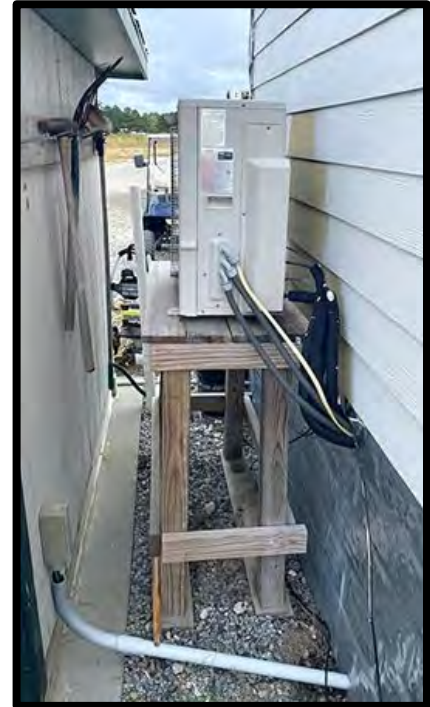
outdoor heat pump coupled to two 1-ton indoor evaporators (wall mounted ductless type). We were unable to determine the age of the systems based on serial numbers, but they appear to be in good operating condition. It does appear however that at some point the building had a central HVAC system, which is evident by improperly patched ceiling openings where the supply diffusers once were. Ceilings should be properly patched to limit air infiltration and increase buildings thermal efficiency. Outdoor heat pump is installed too close to the building limiting its operational and service clearances. Restrooms have individual exhaust fans, but do not have heating and cooling - they rely on adjacent space air to provide conditioning and freeze protection. At a minimum we recommend adding small electric unit heaters to the restrooms to ensure they will always stay above freezing. To address outdoor unit relocation, add unit heaters to the restroom, and patch the ceiling, approximate construction budget is \$7,500.

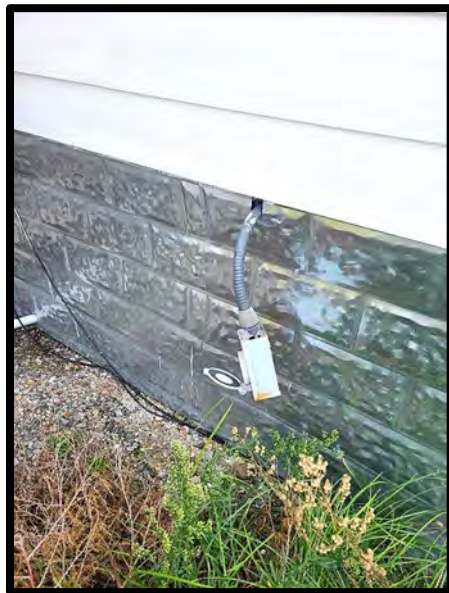
The existing electrical service for the Dockmaster building appears to be rated 200-amps at 240/120V, 1-phase, 3-wire, and is adequate for the proposed use. The electrical distribution equipment consists of a single main distribution panelboard manufactured by Square-D. This equipment is in fair condition and is of currently supported manufacture. This equipment could be reused as part of any renovations but recommend replacement if the building is replaced in its entirety.

Exterior power equipment adjacent to the Dockmaster building is in fair condition but located in an area primarily used for storage. Stored materials should be relocated to ensure the necessary 36" code required working clearance in front of all electrical equipment.
